RoHS Assessment Report

for Directive 2011/65/EU on Restriction of The Use of Certain Hazardous Substance (RoHS) in Electrical and Electronic Equipment.

Product/Sample: Variable Frequency Drive

Style/Type: EVO6000(2)

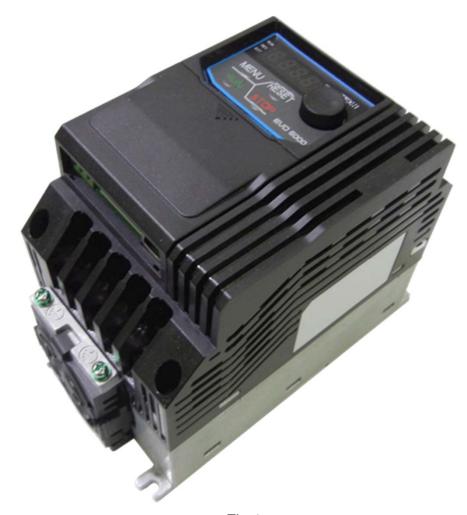
Fig.1

Product/Sample: Variable Frequency Drive

Style/Type: EVO6000(2)

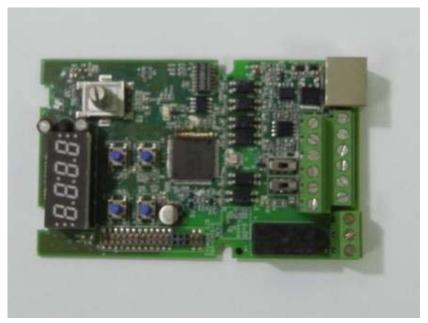
Fig. 2a PCB-1 (Front view)

PCB Sample Photo

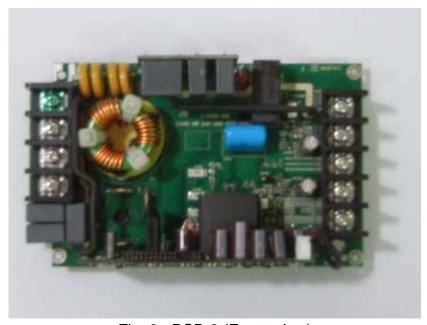
Fig. 3a PCB-2 (Front view)

PCB Sample Photo
